GILKERSON DAM

(NDI Number PA-01122)

PHASE I INSPECTION REPORT.

Gilkerson Dam, Westmoreland County, Pennsylvania
NDI No. PA 01122, PennDER No. 65-8
Unnamed Tributary to Beaver Run
Inspected 18 March 1980

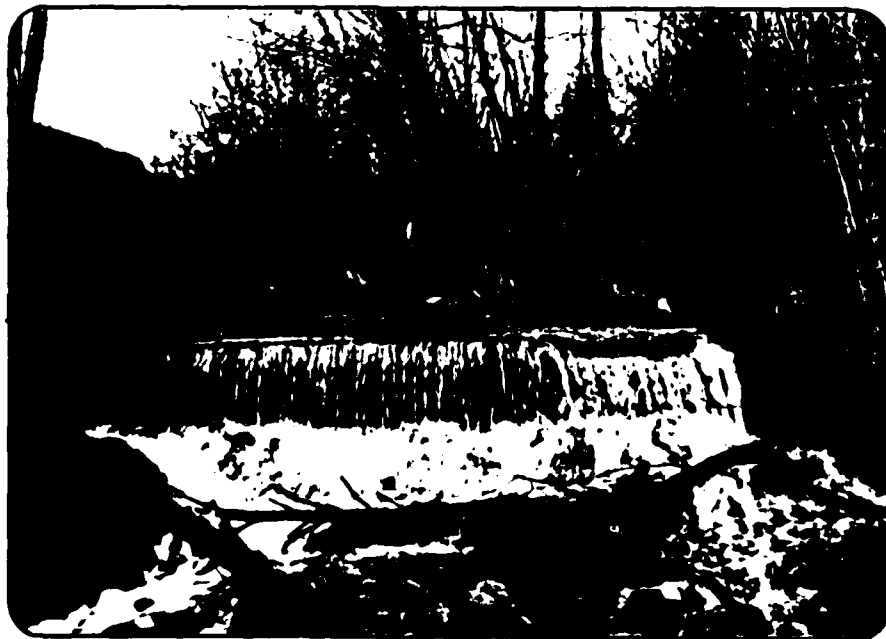
The control section of the spillway is a concrete weir 19.4 feet long (perpendicular to the flow). At and just above the control section, the concrete in the left half of the spillway and on the training walls is badly deteriorated and eroded. The left quarter of the spillway is filled with soil out of which bushes and small trees are growing. The left half of the riprapped approach channel is filled with soil out of which bushes and small-to-medium size trees are growing. The rest of the approach channel is almost completely blocked with a large number of floating logs.

PHOTO 2. Looking Upstream at Spillway

- 4) The eroded and deteriorated concrete in the spillway should be repaired; the riprap in the lower portion of the discharge channel should be repaired.

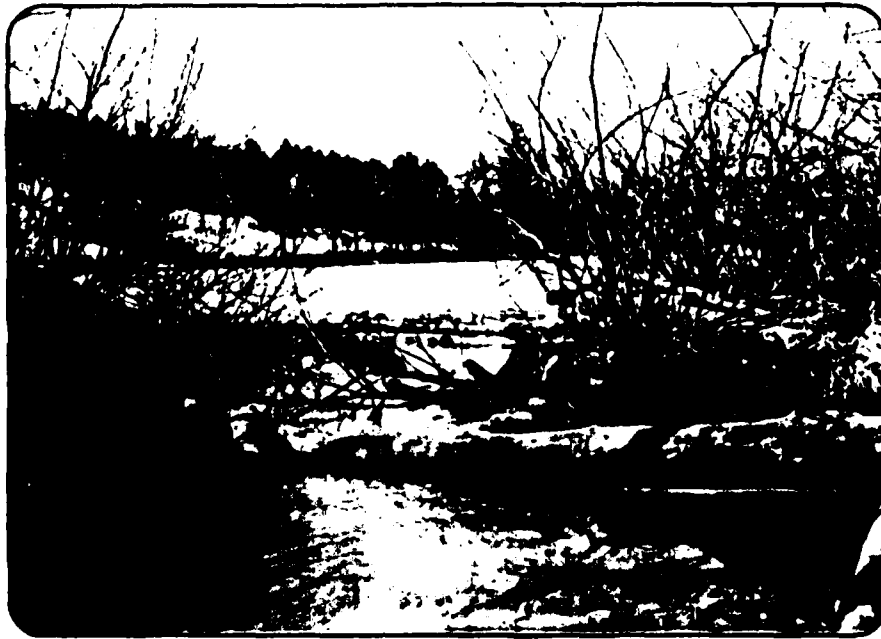
PHOTO 3. Looking Upstream at Logs in Spillway Approach Channel
